John Weaver
Cornerstone Building Analysis, Inc.
(407) 518-1211
PO Box 452973 Kissimmee, FL. 34745
www.cornerstonebuildinganalysis.com
john@cornerstonebuildinganalysis.com

Inspection Conditions

DATE OF INSPECTION: 5/2/13.
TIME OF INSPECTION: 4 pm.
CLIENT NAME: John Doe.
INSPECTION SITE: 123 Dream House St.
**INSPECTION SITE CITY/
STATE/ZIP:** Central Florida.

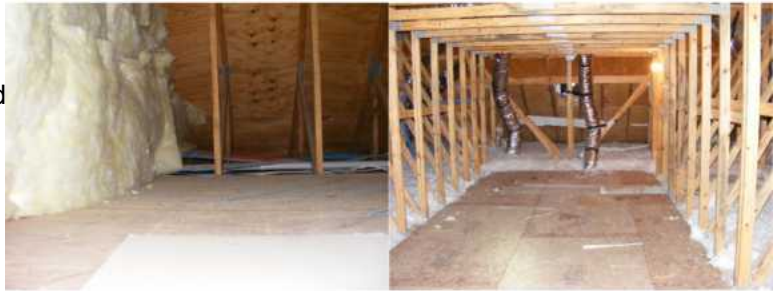
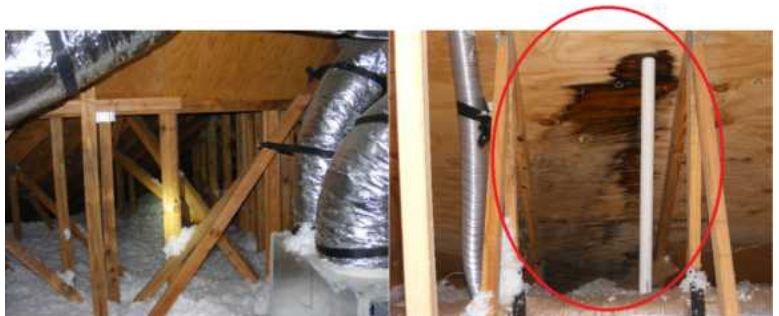
Attic is full size, Truss framing, Accessible at 2nd story, over apartment and over garage. Leak over 2nd story attic at vent pipe. A licensed roofing contractor should be called to make further evaluation and repairs as needed.

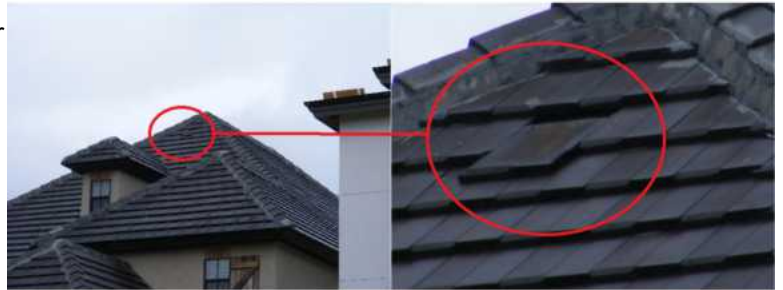
STYLE: Hip.
TYPE: Tile.
ROOF ACCESS: Unable to fully access due to height/pitch/weather/type, Viewed from ground with binoculars.
ROOF COVERING STATUS: Appears serviceable/within useful life. 1 loose tile at front upper hip. A licensed roofing contractor should be called to make further evaluation and repairs as needed.

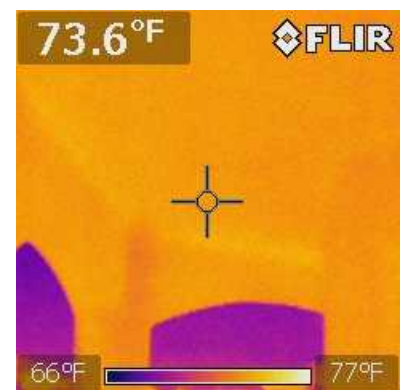
CONDITION: Have contractor check porch railing connections to floor for potential leaks.

TYPE: Same as structure. IR camera does not show significant temperature differences with rain at time of inspection.

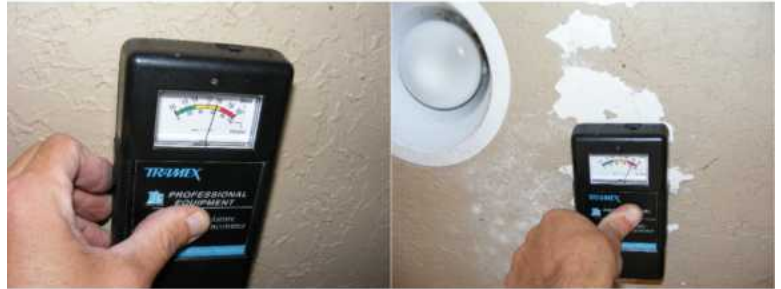
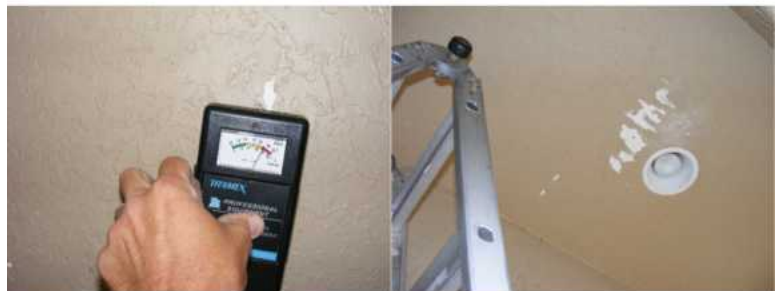
Rear porch ceiling reads wet with moisture meter at the time of inspection, ceiling shows normal temperatures for conditions present with IR camera at the time of inspection. Recommend having contractor penetrate ceiling and scope subfloor to determine extent of moisture, source of leaks and estimates for repairs.

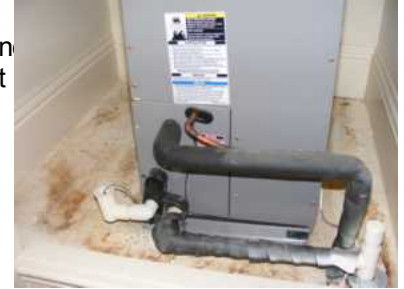
Appears serviceable, Routine service/maintenance advised to clean condenser coils, clear condensation line and check unit for proper operation. Surface mildew at apartment air handler, clean as needed, this does not appear to be a catastrophic mold situation. A mold inspection is not part of this home inspection.

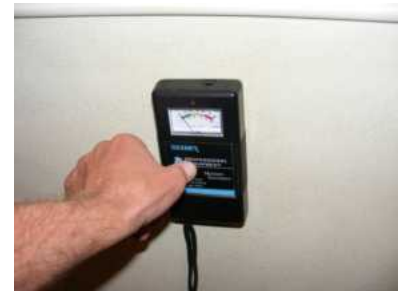
TYPE & CONDITION: Aluminum, Single hung, A representative sampling was taken. Windows as a grouping are generally operational. Walls under windows read dry with moisture meter at the time of inspection.

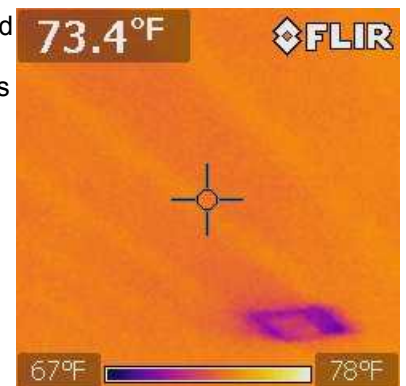
MATERIAL & CONDITION: Drywall, General condition appears serviceable, Stored items or furnishings prevent full inspection, Infra-red thermal scan shows normal temperatures for conditions present at time of inspection.

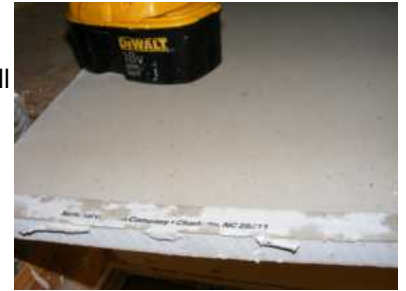
TYPE & CONDITION: Drywall, General condition appears serviceable, Infra-red thermal scan shows normal temperatures for conditions present at time of inspection. Ceiling drywall hatch labeled "National Gypsum, Charlotte, NC."

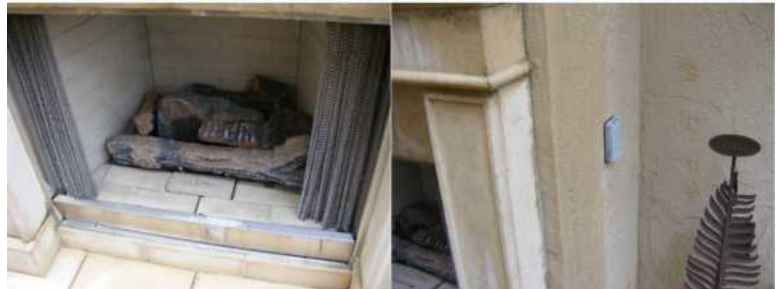
LOCATION - TYPE - CONDITION: Prefabricated metal unit in courtyard. Unit failed to light, switch cover loose. Have gas appliance tech. advise. Summer kitchen grill failed to ignite, have gas appliance tech. advise.

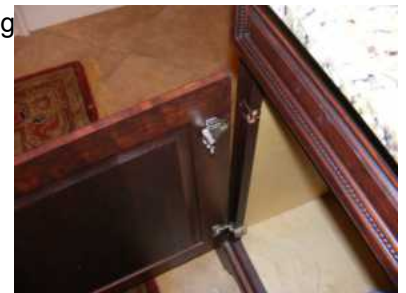
BATH LOCATION: Master bedroom.
CONDITION OF SINK: Appears serviceable, Drain appear serviceable, Damage is noted at counters/cabinets, broken hinge.

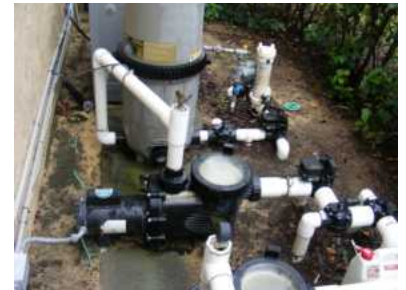
LEAKAGE? Rain at time of inspection makes detecting small leaks impossible. Air in system is symptom of minor leak on return side. Have pool tech. advise.
LEAF BASKET: Minor air bubbles- Monitor and repair if their frequency increases.
PRIMARY FILTERING: Diatomaceous earth.
CHLORINATOR: In-line type.
